Boston's Open Space

1987 PARK EVALUATION & SITE SUMMAPIES

EVALUATION OF CITY OF BOSTON PARK AND RECREATION LAND

NEIGHBORHOOD OF BACK BAY/BEACON HILL

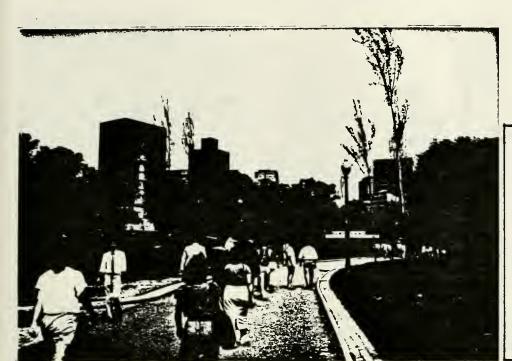
From main entrance opposite Public Gardens. New tree planting doing poorly.

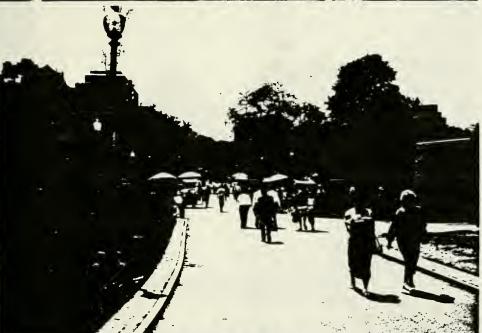
Site Photograph 2

Looking back at entrance. Entry dominated by street vendors.

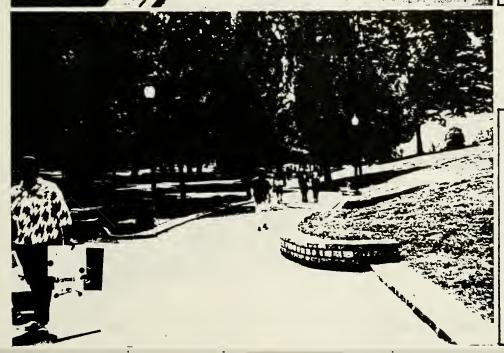
Site Photograph 3

Granite cobble edging installed to prevent areas of eroded grass.

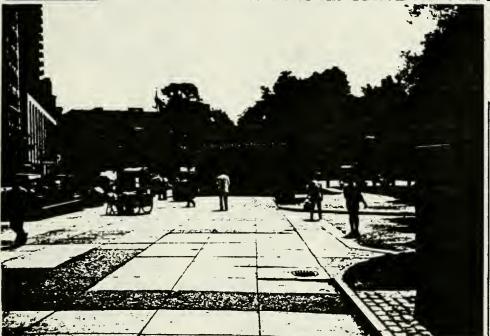
Site Photograph 5

Information center-style of building out
of character with
surroundings.

In general, the design of the improvements along Tremont Street do not well reflect the landscape character of the Common, most particularly the information booth. The park's concrete pedestrian lights are also out of character with the original site improvements.

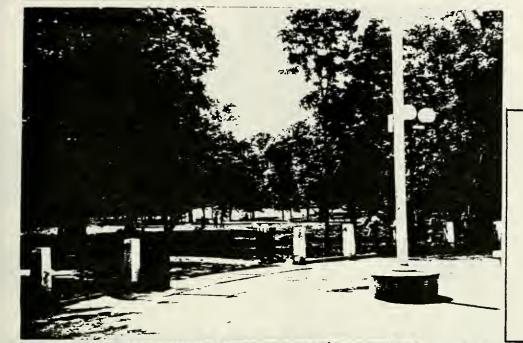
Granite bollards and chain— an effective edging around flag pole area. Light fixtures out of character with park.

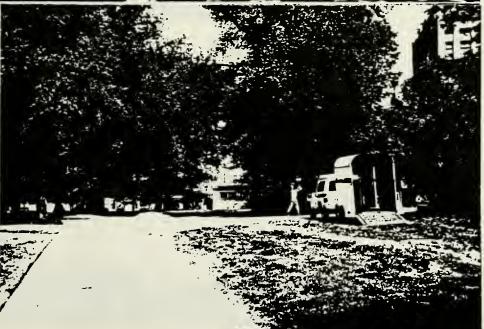
Site Photograph 9

Vehicles should not park on grass.

Although, as a whole, the Common appears to be in fair to good condition, there are numerous renovations to structures necessary, many of which will be addressed in the currently proposed repair work. The greatest overall improvement to the appearance of the park can be gained from improving the lawn areas. Many areas are worn out and compacted, especially near prominent entry points and features. Some areas have an irregular surface and poor grass coverage. An active turf management program is essential, as well as the restriction of cars from driving on the grass.

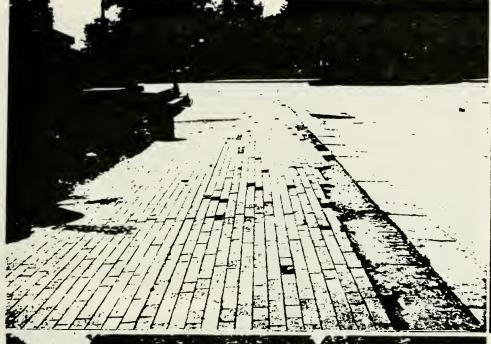
Pavement needs repair.

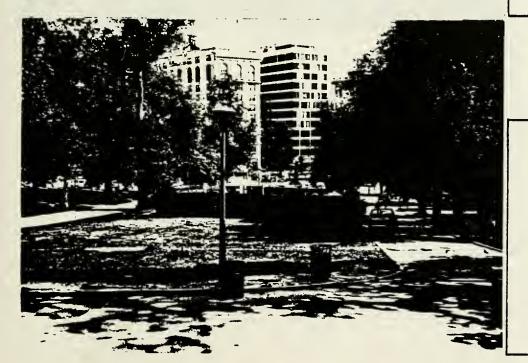
Site Photograph 15

View through site-shows temporary enclosure for construction.

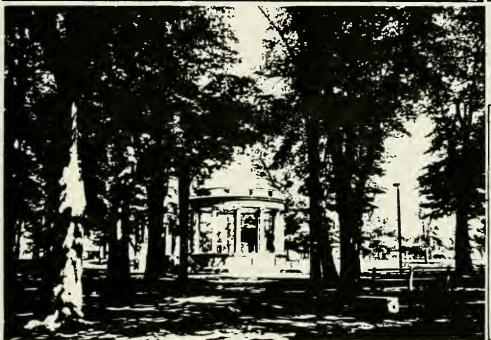
Site Photograph 17

Bandstand.

Most standard park-built elements are in good condition. The statues are in good condition, the bandstand in fair condition, and the comfort station is closed and appears to need major renovation. One fountain appears in fair to good condition but isn't working, and another is working and appears to be in good condition.

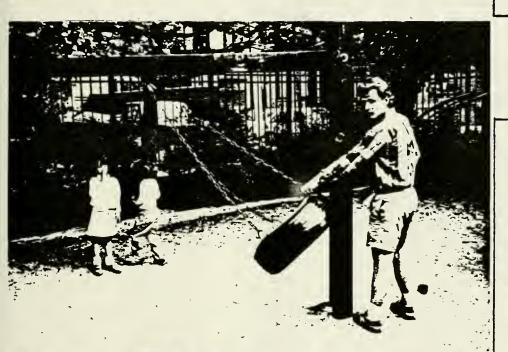
Site Photograph 5

Illustrates how close tire swings are to support post.

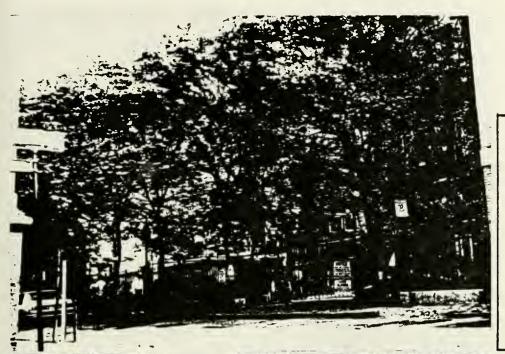
View into the park from across street. Shows steel picket fence around edge with indentation at entrance. Honeylocust provide tall canopy of filtered shade.

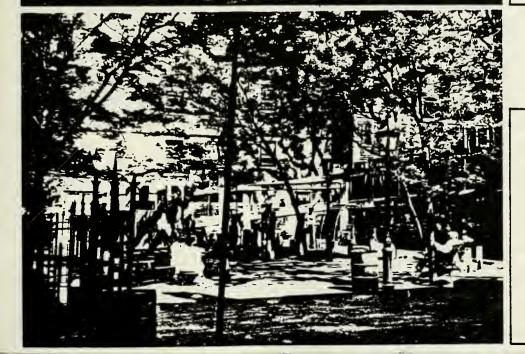
Site Photograph 3

Play equipment in far corner with seating areas in foreground. Gas lamps an easy target for vandals.

Although the gas lighting fixtures are delightful, historic gestures, the glass of the light is a target for play or vandalism.

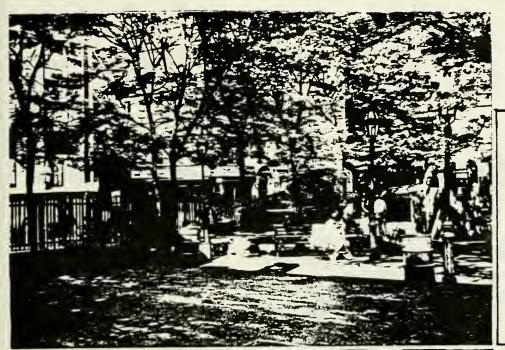
Raised sitting area with planted area behind.

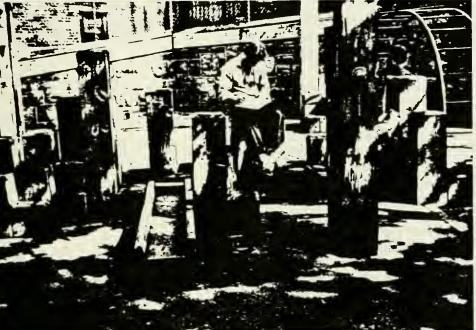
Site Photograph 5

Unusable spray feature.

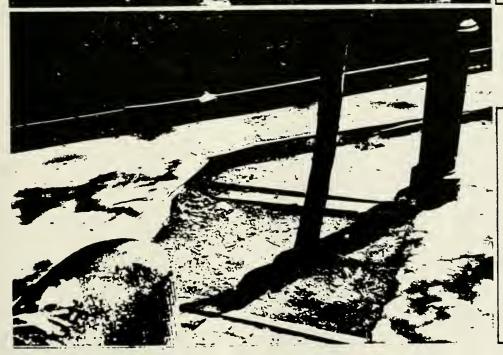
Site Photograph 6

Inadequate planting pit. Note rotting wood edging around edge of safety surface play area.

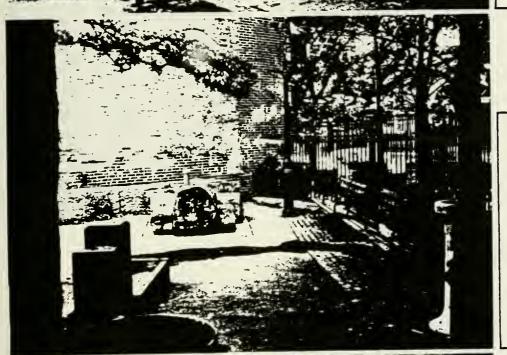
Site Photograph 2

Upper level sitting area and broken apray equipment.

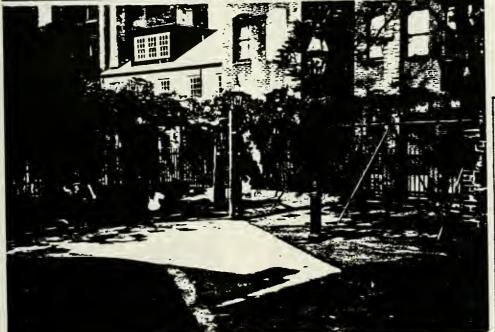
Site Photograph 3

Lower level play equipment, tire swings unusable. Benches needed in far corner.

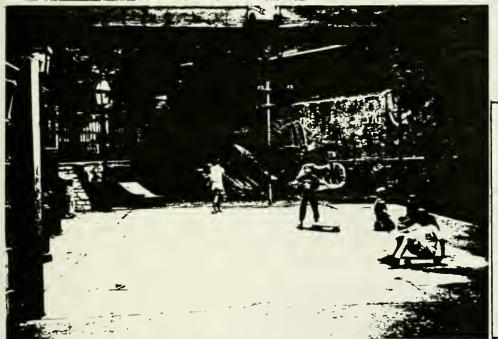
Site Photograph 5

Basketball area with no backboard. Slides and climbing equipment built up against terrace wall.

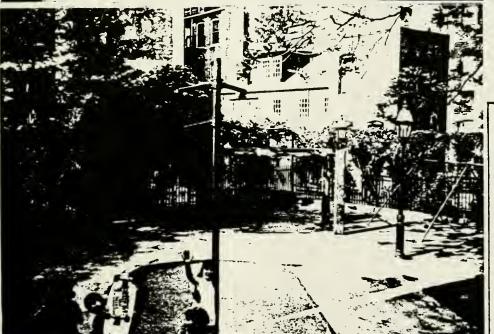
Site Photograph 6

View from upper level. Wisteria from neighboring property enhancing park edge.

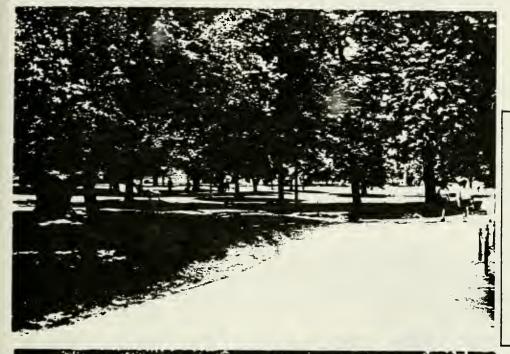
Site Photograph 2

Shrub and ornamental plant beds along edge of park. Cobble edge protects planting beds.

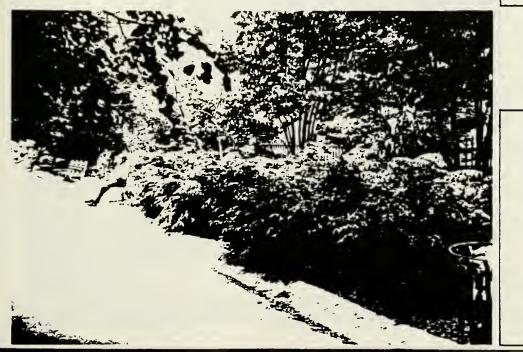
Site Photograph 3

Pruning of shrubs allows natural, graceful character of plants to exist.

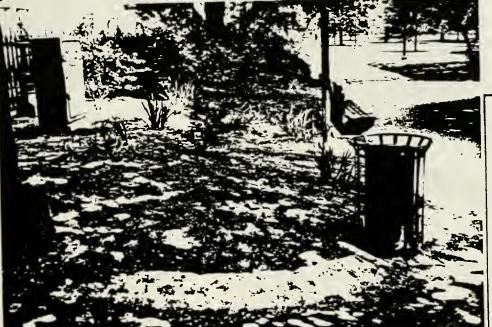
Site Photograph 6

A plant bed that is underplanted.

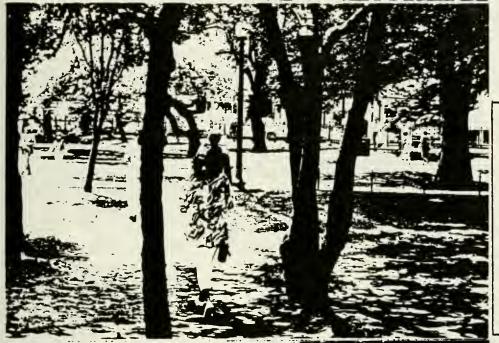
Site Photograph 11

Desire lines through park eroding grass and compacting soil over tree roots.

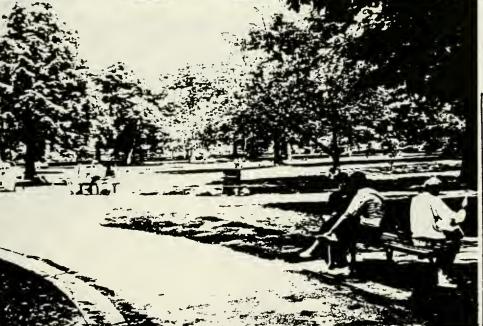
Site Photograph 12

Trash build up around trash barrels.

On the whole, maintenance is very good, with the exception that trash needs more frequent removal from receptacles. The edging around the pond has settled in places and needs repair. Fountains are all in need of repair, and would add immeasurably to the park if in operation. The heavy use of the site is evident in desire lines and worn patches in the grass. Compacted dirt around trees will cause stress by denying water and oxygen intake of the roots.

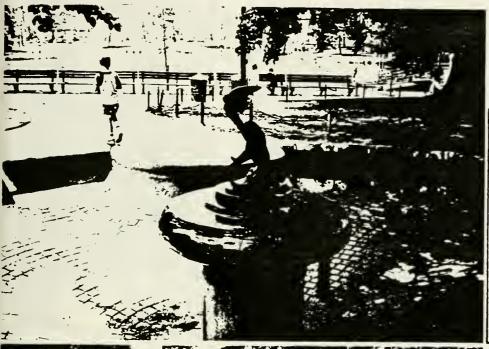
Fountain-- not working.

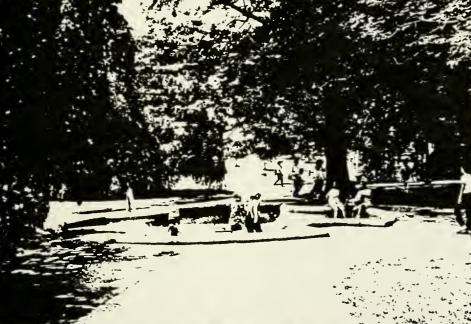
Site Photograph 14

Fountain-- not working.

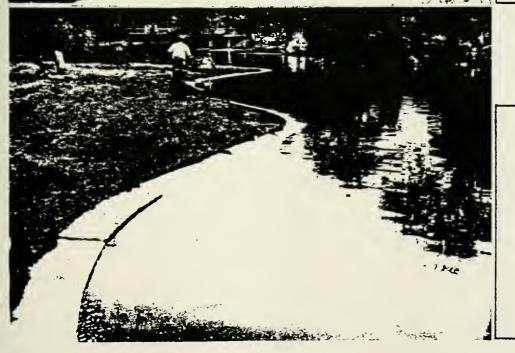
Site Photograph 15

Edging around pond settling in some areas.

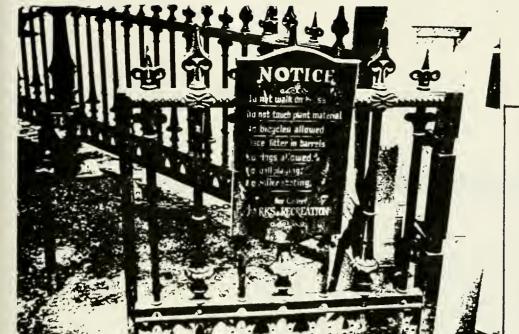
Ornamental fencing and historic sign around edge of park.

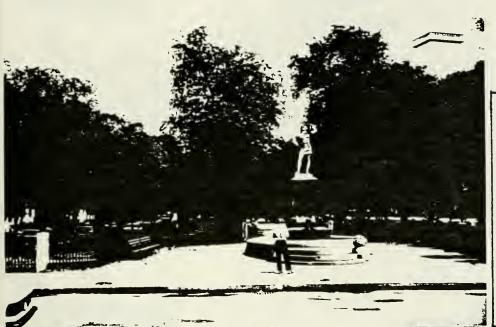
Statue of Lief Ericson at Charlesgate. East end of park. Stone-dust walkway, seating and beginning of linear walk along mall. Many shade trees including Elms behind.

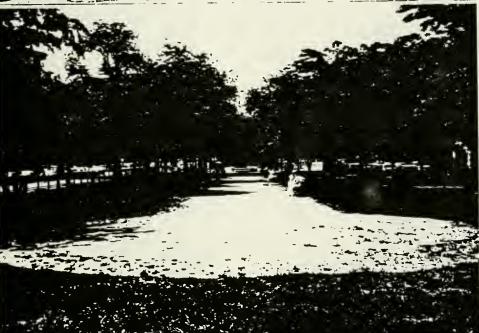
Site Photograph 2

Circular end to east area. Formal planting of trees doing well in lawn.

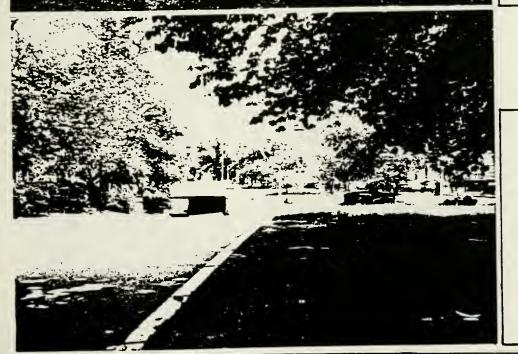
Site Photograph 3

View into underpass below Massachusetts Avenue. Grass very patchy in some areas.

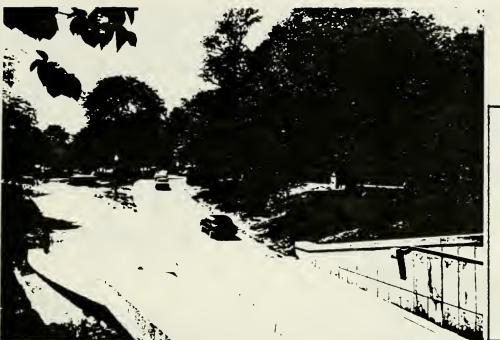
View down from Massachusetts Avenue overpass showing shrub plantings and poor grass.

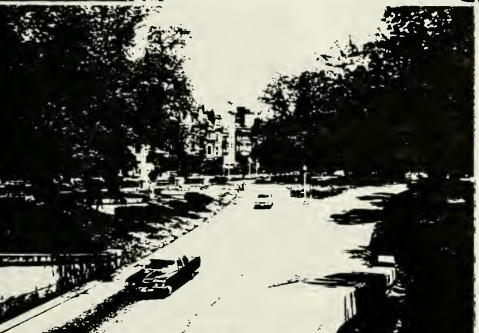
Site Photograph 5

Shrubs old and distorted from over-pruning.
Needs replanting.

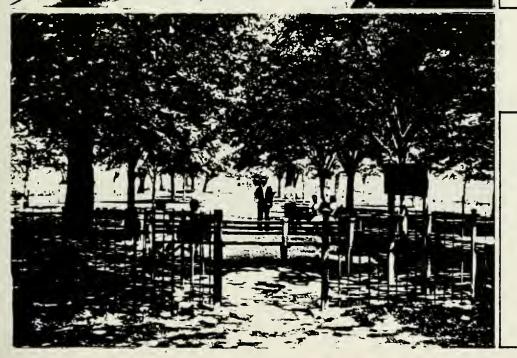
Site Photograph 6

Entry into walkway down mall. Edge defined by steel picket fence.

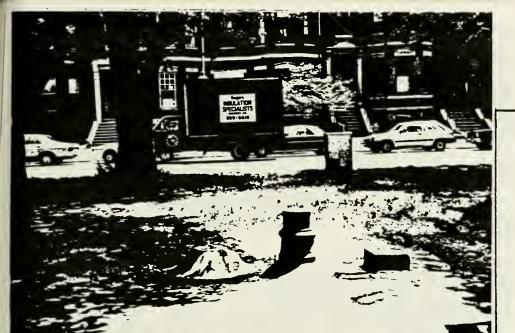
Granite drinking fountain in need of repair.

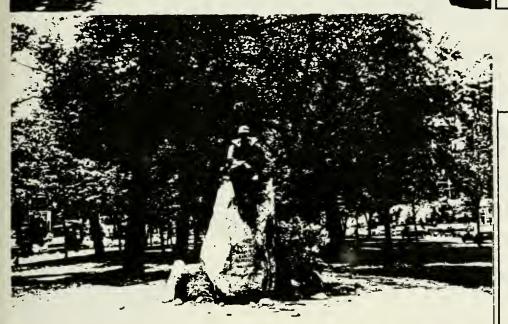
Site Photograph 11

A statue.

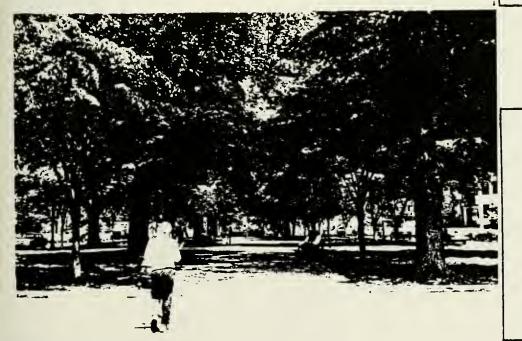
Site Photograph 12

View down center of mall showing mature trees and recently planted replacement trees.

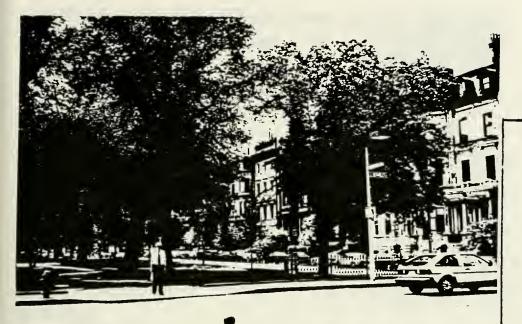
View down mall from Berkeley Street. New decorative metal fencing in the process of being installed.

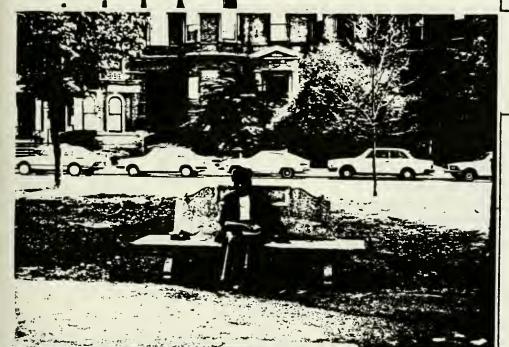
Site Photograph 20

A granite memorial bench.

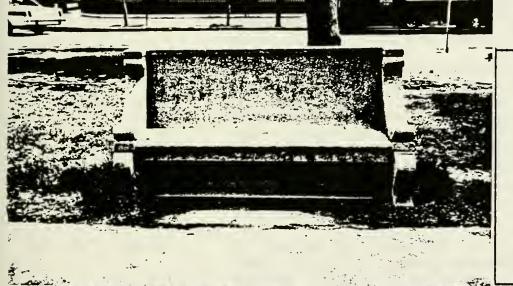
A granite memorial bench.

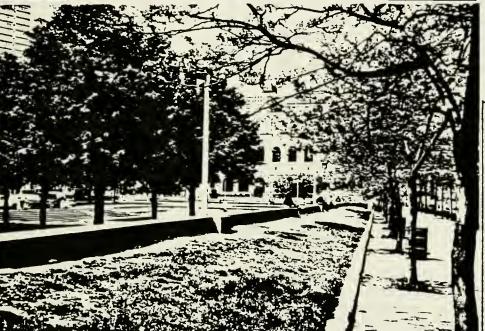
Site Photograph 5

Street edge along Boylston Street with Boston Public Library at far end.

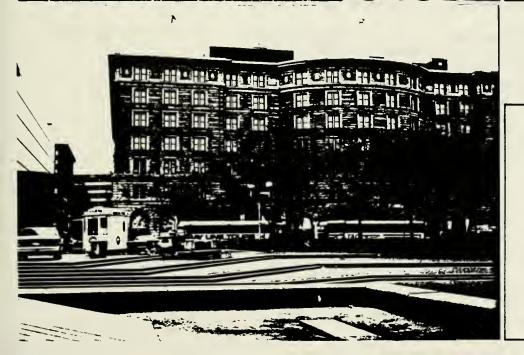
Site Photograph 6

View across site towards Copley Plaza Hotel.

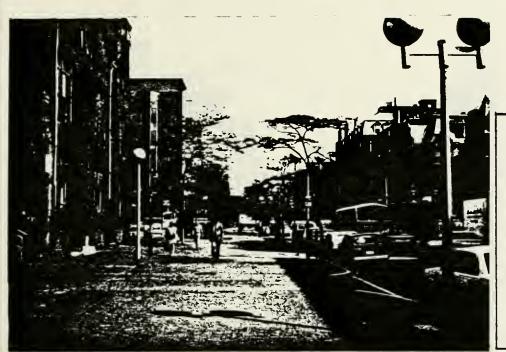
Site Photograph 1

View of block between Boylston and Newbury Streets. Note wide expanse of pavement in relationship to tree canopy. First tree on left typical condition of those to be removed - stunted and malformed.

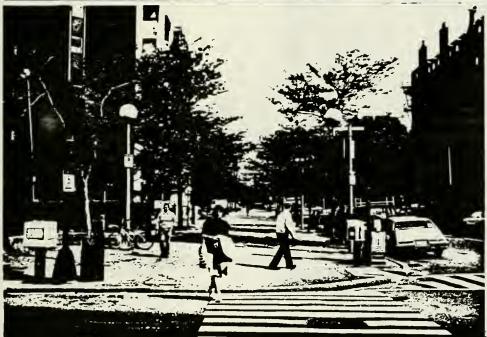
Site Photograph 2

Block between Newbury Street and Commonwealth Avenue. Trees beginning to develop a full canopy.

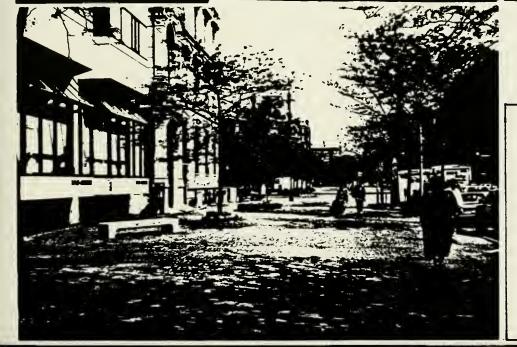
Site Photograph 3

View shows planting of annuals at base of trees. Flowers should be planted on a generous scale. Benches need re-alignment.

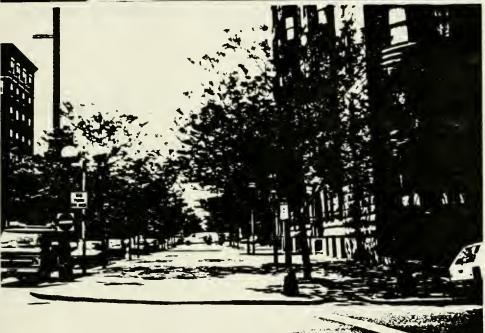
Site Photograph 5

View of corner at Beacon Street.
